# COMPARISON OF AERIAL IMAGING WITH ONSITE PHYSICAL ANALYSIS FOR SOLAR PV ASSESSMENT

## Summary

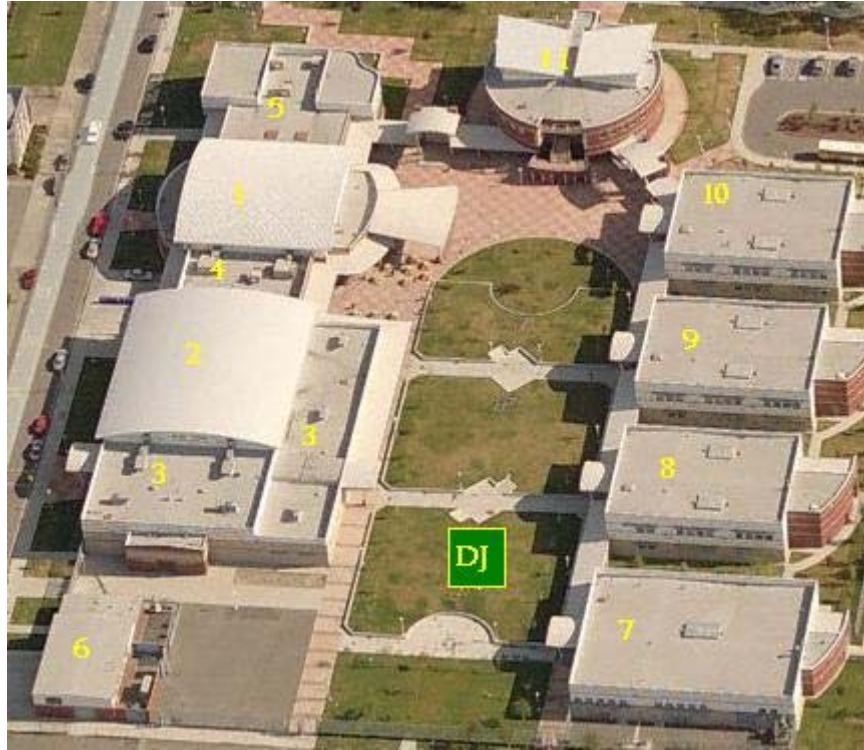
DeJean Elementary School Complex Richmond California  
Oblique Image courtesy of *Pictometry*
